# DEALING WITH COMMON BATTERY MAINTENANCE PROBLEMS

**Rick Tressler**  
**Senior Training Engineer**  
**Alber**  
**Pompano Beach, Florida**

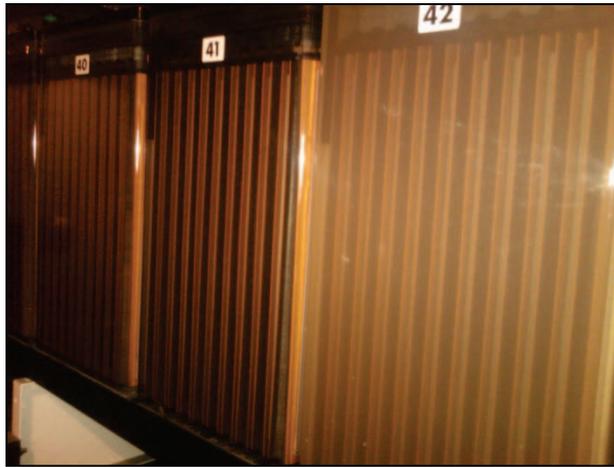
**Figure 1**

Containers used for VLA batteries can be provided to the user in a limited variety of thermoplastic materials. Selection is based on the user’s needs which frequently focus on flammability characteristics of the container material. Among these are SAN (styrene acrylonitrile), poly carbonate and PVC (polyvinyl chloride). From a visual standpoint, the characteristics of the PVC container cause it to appear semi-transparent and yellowish, thus making the electrolyte inside appear to be off-color, or “milky” as one customer put it to me. To someone who is accustomed to seeing PC or SAN containers, they might think there is a problem with the battery. Actually, it’s all good, as some might say. The problem is you won’t find an obvious label on the battery that indicates the type of plastic you’re looking at. You would have to go clean back to the order to find it in most cases. Figure 1 shows a somewhat unique instance where PVC containers (right) were installed along side SAN types in the same battery string. Operationally there is no difference between these materials with one exception; PVC is flame retardant and SAN is not.

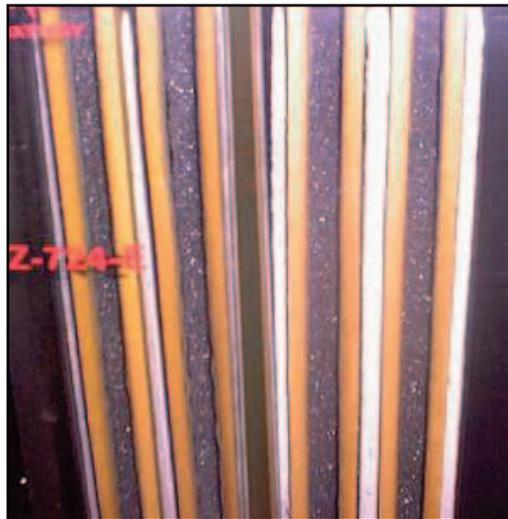
**Figure 2**

Visual inspection criteria include the recommendation for a detailed look at all cell elements in a battery once every 12 months, according to IEEE 450-2010. You're supposed to be looking for color and uniformity of both positive and negative plates. Okay, a quick review; negatives are supposed to be light gray and positives dark brown to black, matte surface appearance. A good bright flashlight is needed here. If you've spotted what appear to be "crystals" or "sparkles" on the positive plates on all cells in the battery, this is not normal and it's not a good thing. See Figure 2. That's lead sulfate on the positive plates. It occurs when a battery has been discharged or is being under charged. Chances are, unless there's been a very recent discharge, the charger is providing too-low a voltage to the battery. Check the float voltage at the battery's main terminals and check *that* against the battery maker's recommended float specification. If it's low, raise the float as needed. It's a very common problem and many don't know how to recognize it. Now you do! What if this is observed on just one cell? Then we have an individual cell that has a problem and will likely need replacement.

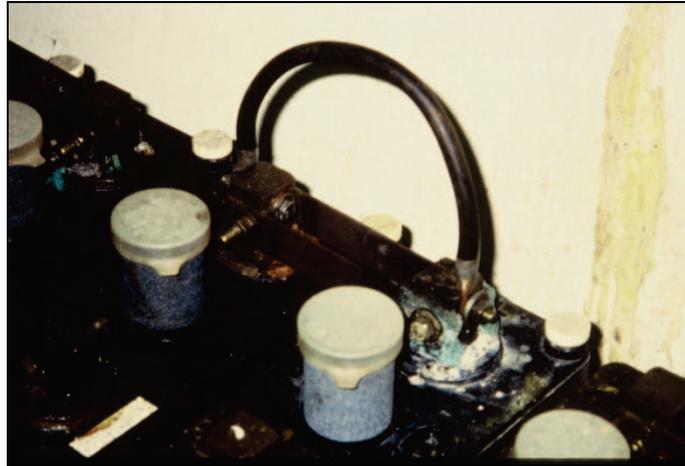
**Figure 3**

Along the lines of periodic visual inspection, there are numerous things to look for and some of them can really jump out at you. Even though that happens, people generally don't always know just what they're looking at. Take the photo provided in Figure 3 for example. You're looking at corrosion that's fairly advanced. It's green and fuzzy looking because electrolyte has come in contact with the copper, under that lead plating on the inter-cell connector, creating copper sulfate. You'll have to deal with this sooner or later. It might as well be the former because these problems are not self-repairing. Those who don't correct these problems just wait until a discharge happens to find out just how badly corroded connections can affect capacity. In extreme situations the excessive  $I^2R$  losses blows the connector clean off the battery, leaving a melted stump of a terminal, also known as an open circuit and a dumped load.

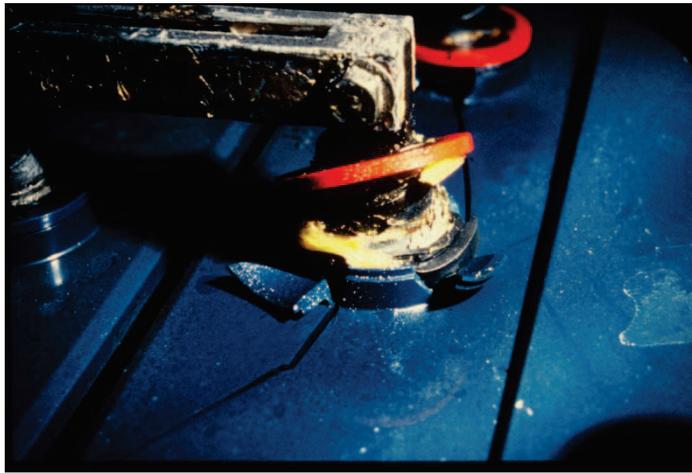
Figure 4

As a battery ages, the positive grids corrode. This is also known as "growth" and it's well understood in the industry. It is the primary determining factor in when it's time to have a retirement party for a battery. In addition to this condition occurring as the battery approaches its end of life, the plates will eventually extend down to the bottom of the cell and at that point, there's nowhere to go but up. Refer to Figure 4. Here's one reason why you'll see the positive terminals pushing up out of the post seal, exposing an unusual amount of lead above the cover. In many cases, the post seal and surrounding area has limited flexibility to allow the added growth. As a result, the cell cover cracks. Don't bother breaking out your ohmic testers or load banks. Batteries that look like this are on death's doorstep. What's not expected is to see this occurring early in battery life. This condition can be accelerated with high operating temperatures, excessive and unnecessary cycling and over charging.

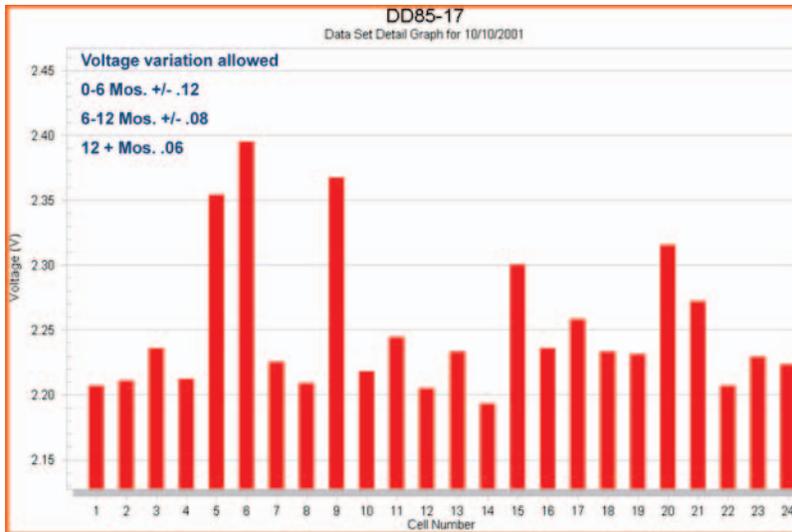
Figure 5

At some point, you may come across a battery that exhibits a wide array of cell voltage deviations as illustrated in Figure 5. The battery is a VRLA type with a set of float voltage readings taken only 20 days after installation. The technician expected +/- .01 volts per cell deviation and instead observed this, thinking the battery was in serious trouble when in fact it was not. The issue here is not the battery, rather, the battery technician's level of training and understanding. Note the allowable deviation by the manufacturer in the upper-left of the figure. A wide range is acceptable early in battery life and is narrowed as it progresses through the first 12 months of service. The higher voltage cells are likely a bit more saturated than their counterparts in the string and that's why they look like this. A quick review of the installation and operation instructions would have revealed this had the technicians looked it up.

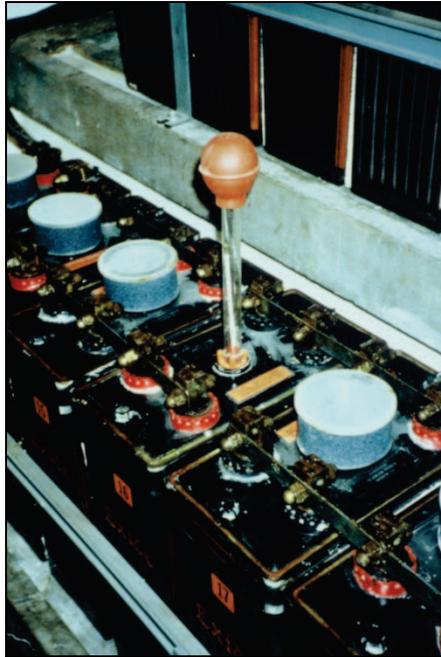
Must be bad post seals right? Loose flame arrestors? That might be it. Sure, it's easy to just blame the battery. Take a good look at how water additions are being conducted on your site. Carelessness creates major housekeeping problems for VLA battery operators. Another sure fire way to contaminate covers, container and hardware is to be sloppy with the hydrometer. Water spillage that doesn't get cleaned up is one thing, but spreading electrolyte all over the place is an open invitation for connector and terminal corrosion. Cleanup is time consuming and expensive. Electrolyte migrates and acts like tiny resistors to ground that create cell voltage imbalances, grounds and shock hazards. Figure 6 is an example of how a battery should not be maintained from the housekeeping perspective. And, by the way, the vent well is NOT to be used for hydrometer storage, please. Where's the flame arrestor anyway?

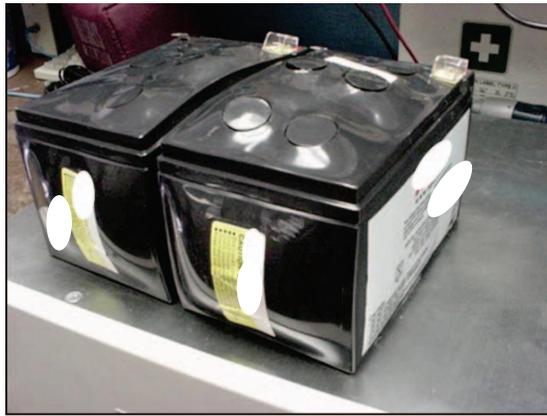
**Figure 7**

Thought by some to be a condition brought on by increases in internal pressure from gassing, container bulge such as observed in Figure 7 occurs primarily in VRLA batteries due to growth of the positive plates. Tremendous pressure is created here in all directions. There is virtually no room for more than a minimal amount of growth. Cases such as this one occur when batteries are subjected to overcharge, prolonged periods of operation at high ambient temperatures, excessive cycling, significant aging beyond expected life or a combination thereof. Thermal runaway likely occurred here. If you observe container bulge be cautious. A small amount of bulge is normal. When it becomes pronounced, the battery is getting closer to replacement time. The type of battery illustrated in Figure 7 is 12 volts and approximately 12 amp hours in size. It was installed in a small UPS in the same compartment with the heat generating power electronics. It's no wonder it looks like it does due the heat exposure, but this can happen to any VRLA battery at any time, given the right conditions. Figure 8 represents a new battery module and was used for comparison purposes.
